Manhole Inspection Summary

Manhole # S41C__050MH

Insp Date: **12/30/08 10:13 AM**

Location Address: **n caroline st**

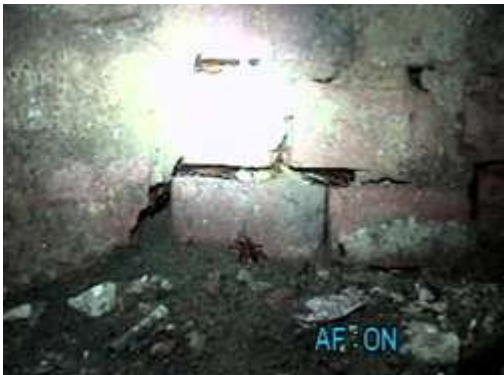
Defect 4

Condition: ☐ Sound ☐ Cracked ☐ Root Intrusion ☒ **Loose Brick** ☒ **Deteriorated**

barrel loose bricks and deteriorated,
missing grout around pipes

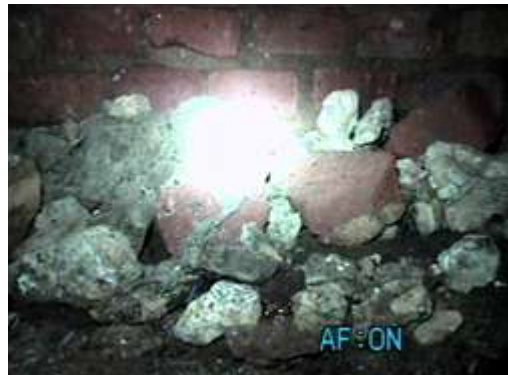
Defect 3

Condition: ☐ Sound ☐ Cracked ☐ Root Intrusion ☐ Deteriorated ☐ Leaks ☒ **Debris**

bench debris

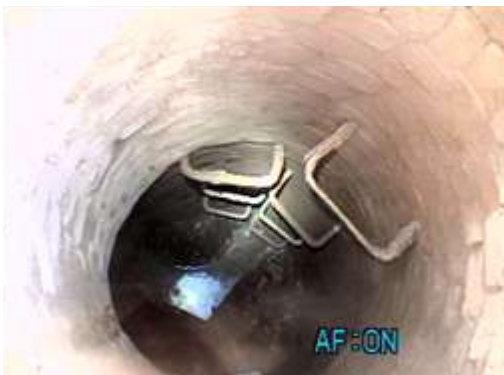
Defect 2

Steps Count: **7** Missing: **0** ☒ **Corroded**

steps corroded

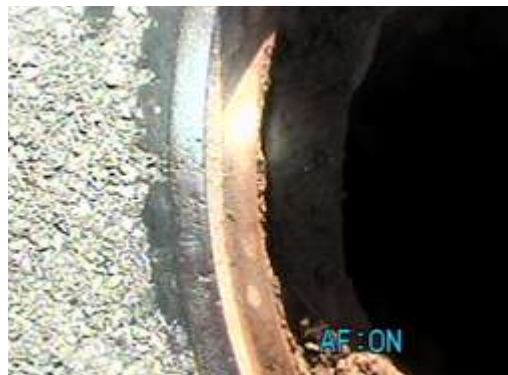
Defect 1

Frame Offset: **3** (in.) Condition: ☒ Sound ☐ Cracked ☐ Leaks

frame offset 3 inches
